**AIRCRAFT ACCIDENT  
INVESTIGATION REPORT**

**ALL NIPPON AIRWAYS CO., LTD.  
J A 6 1 0 A**

AIRCRAFT DAMAGE CAUSED BY HARD LANDING  
ALL NIPPON AIRWAYS CO., LTD.  
BOEING 767-300, JA610A  
NARITA INTERNATIONAL AIRPORT  
AT ABOUT 13:23 JST, JUNE 20, 2012

July 8, 2016

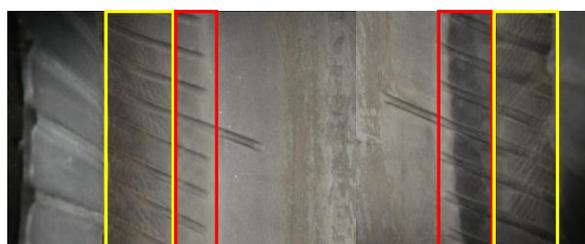
Photo 2.8.4-2 Inside of nose landing gear tire

Since signs of contacts among inner surfaces of the tire of the nose landing gear and wrinkles were found on the entire inner surface of the tire, it was highly probable that the tire rotated once or more times with its inner surfaces of the nose landing gear contacting with each other. (See Photos 2.8.4-1 and 2.8.4-2. The contact signs are enclosed by red and wrinkles by yellow.)

The tire manufacturer estimated that the load which caused the contacts between inner surfaces of the tire was three times (72,300 lb) or more larger than the designated load (24,100 lb) when the tire of the nose landing gear had the designated

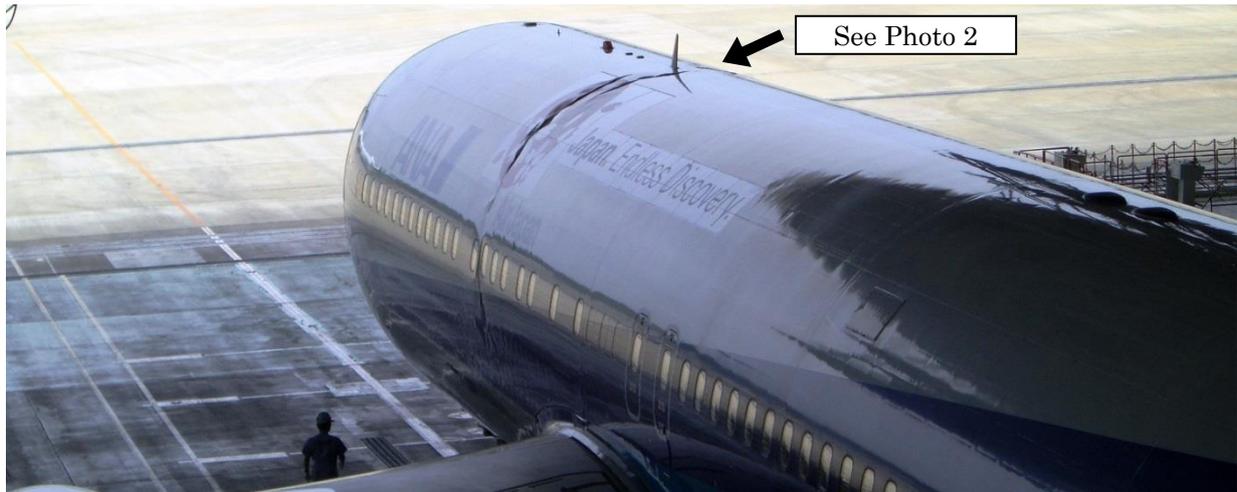
Photo 1 Aircraft Involved in the Accident

Fracture, deformation, and distortion (STA\*9654+22-654+66) in the forward fuselage upper crown and minor distortion near the nose landing gear retraction door (STA276-303) were found.

(See Photo 1: Aircraft Involved in the Accident; Photo 2: Fracture and Deformation of Outer Panel and Structural Component)

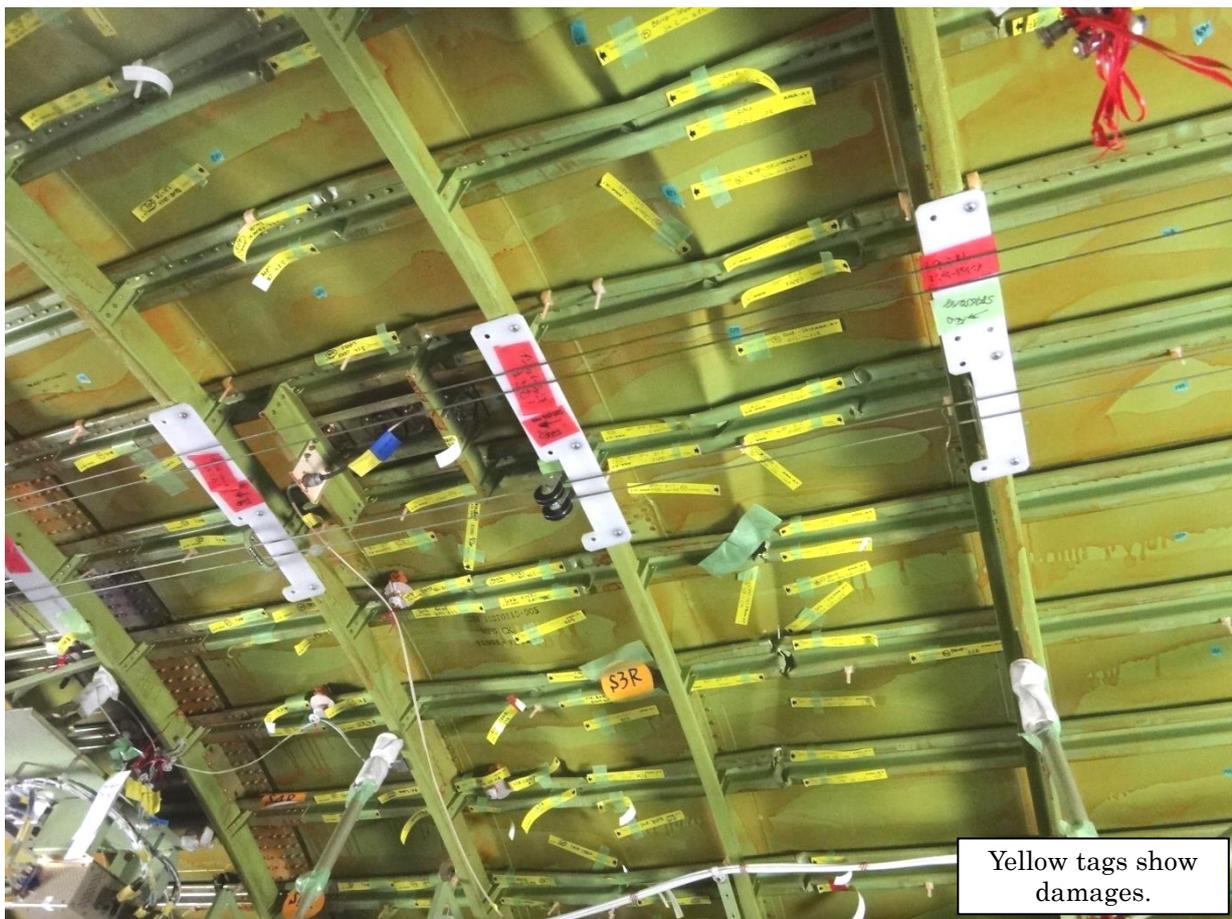
Photo 2 Fracture and Deformation of Outer Panel and Structural Component

Cracks and deformation on a frame (STA654+44) and 36 stringers (STA654-654+110) of the fuselage were found.

Simple analysis of the fracture of the damaged outer panel on the fuselage upper crown found in the aircraft investigation indicated a possibility of fatigue failure; accordingly, a detailed analysis was entrusted to NIMS. As a result, there was no sign of fatigue failure on the fracture and it was highly probable that the fracture was a ductile fracture caused by overload.

Yellow tags show damages.

\*Photo 2 was taken for the part indicated by the arrow in Photo 1 from inside of the aircraft.
