**AIRCRAFT ACCIDENT  
INVESTIGATION REPORT**

**ALL NIPPON AIRWAYS CO., LTD.  
J A 6 1 0 A**

AIRCRAFT DAMAGE CAUSED BY HARD LANDING  
ALL NIPPON AIRWAYS CO., LTD.  
BOEING 767-300, JA610A  
NARITA INTERNATIONAL AIRPORT  
AT ABOUT 13:23 JST, JUNE 20, 2012

July 8, 2016

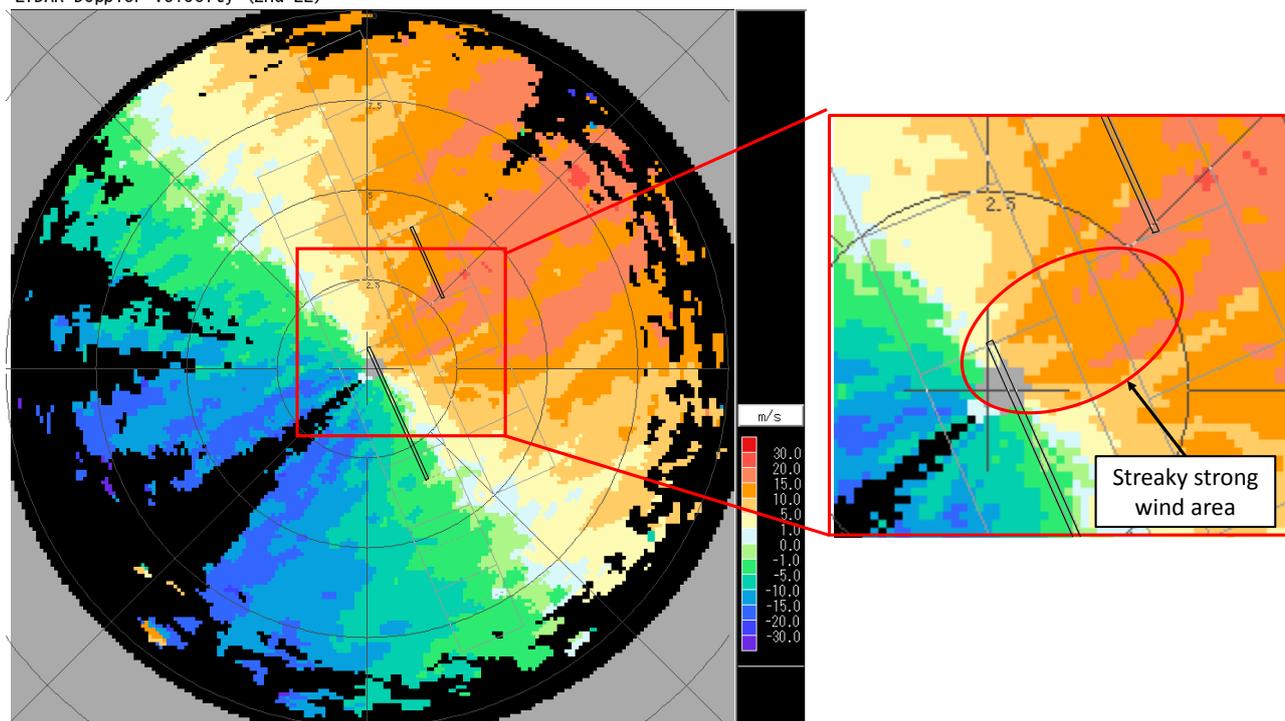
Fig. 2.6.3 (1) Doppler velocity observation data (elevation angle 2°)

According to the Doppler velocity observation data of 13:21:43, cold colors of the velocity component approaching the LIDAR site clearly distributed on the southwest side of the Doppler LIDAR (at the azimuth angle of about 140° to 320°) and warm colors of the velocity component leaving the LIDAR site clearly distributed on the northeast side of the Doppler LIDAR (at the azimuth angle of 320° to 140°); accordingly, the southwest wind was blowing. There was a streaky strong wind area extending parallel to the wind direction, covering the threshold and touch-down zone of Runway 16R.

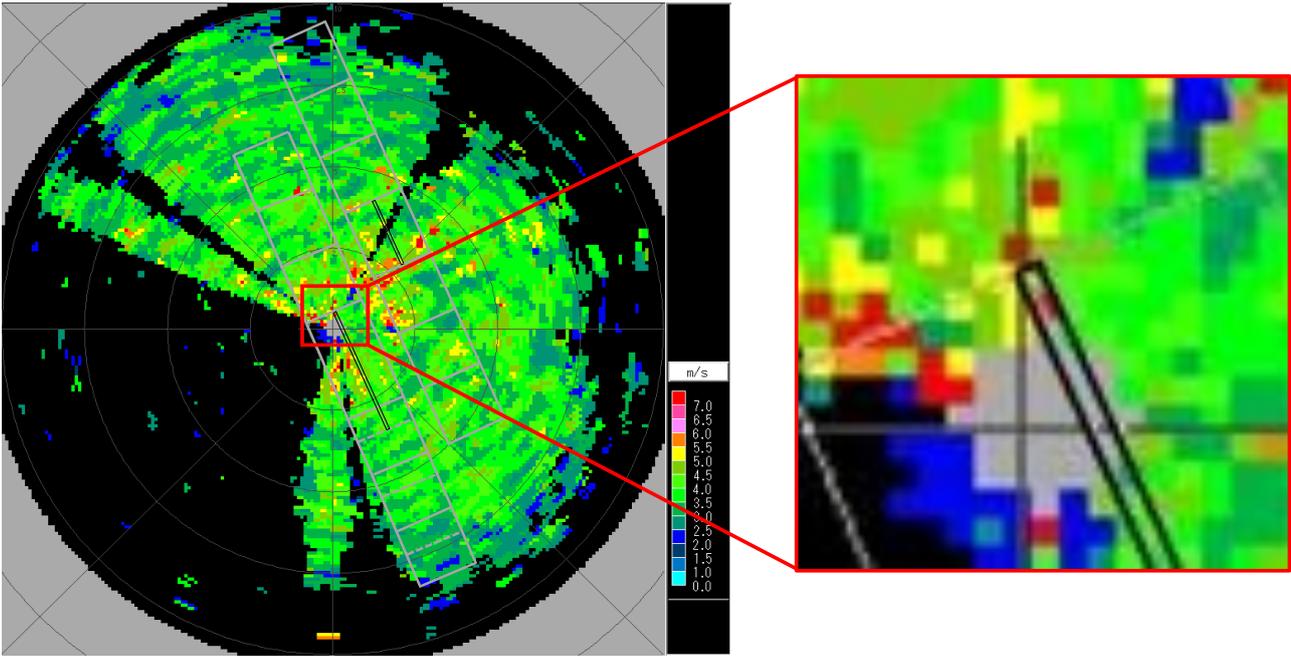
Fig. 2.6.3 (2) Velocity spectrum width observation data (elevation angle 1°)

According to the Doppler velocity spectrum width observation data of 13:22:20, a velocity variation of 7.0 m/s or larger, presented by red color, was observed around the threshold and touch-down zone of Runway 16R, indicating the presence of strong turbulence.

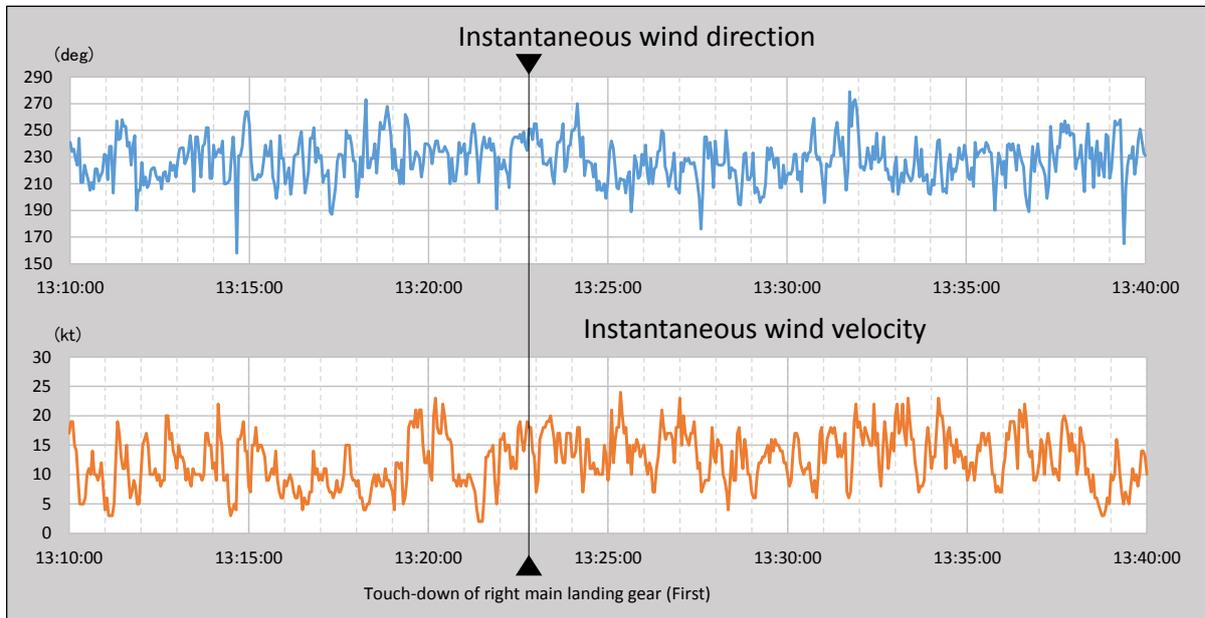
Fig. 2.6.4-1 Instantaneous wind direction and velocity observation data

According to this, from 13:10:00 to 13:40:00, the wind direction was variable between 160° and 280° and the wind velocity fluctuated in the range from about 2 kt to 24 kt.

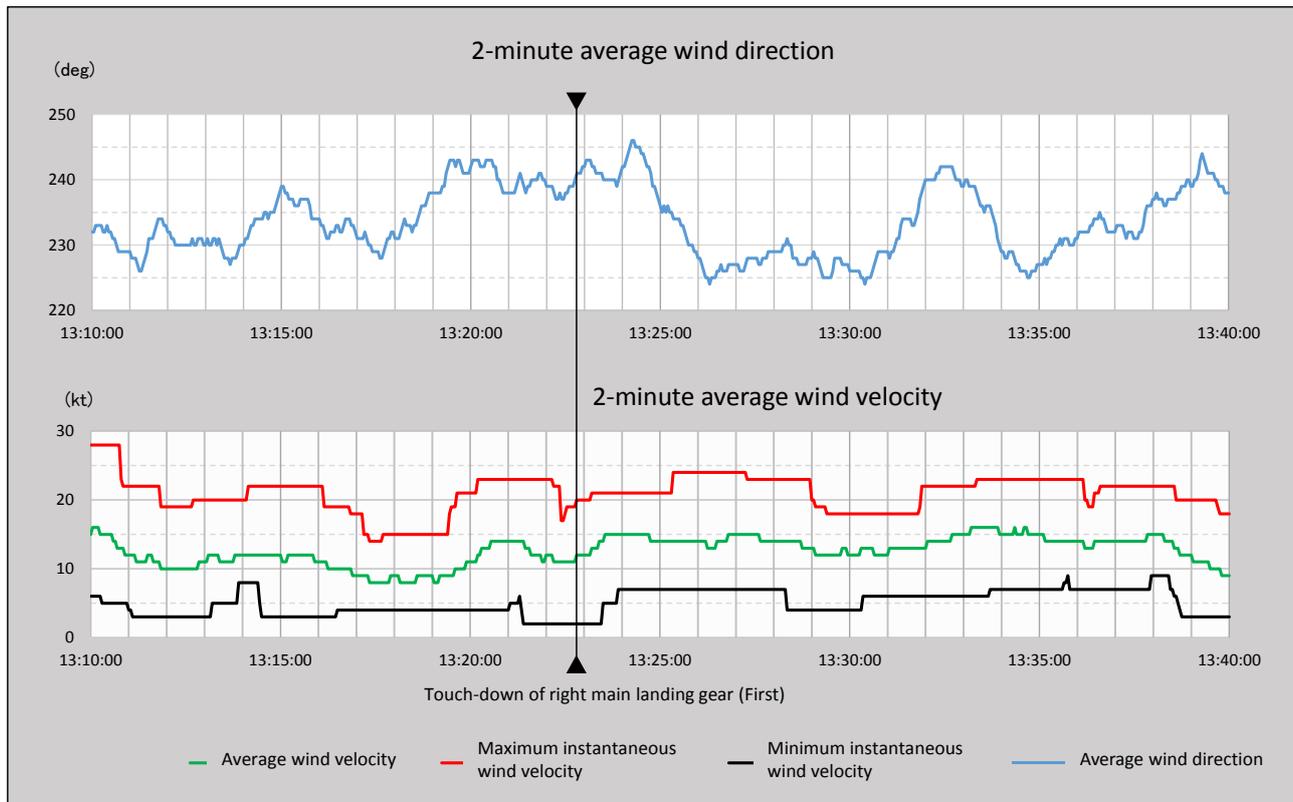
Fig. 2.6.4-2 2-minute average wind direction and velocity observation data

In addition, according to the two-minute average wind direction and velocity data (See Fig. 2.6.4-2), the maximum instantaneous wind velocity at that time varied between about 14 kt and 28 kt, the minimum instantaneous wind velocity varied between 2 kt and 9kt, and the wind direction varied between about 225° and 245°.

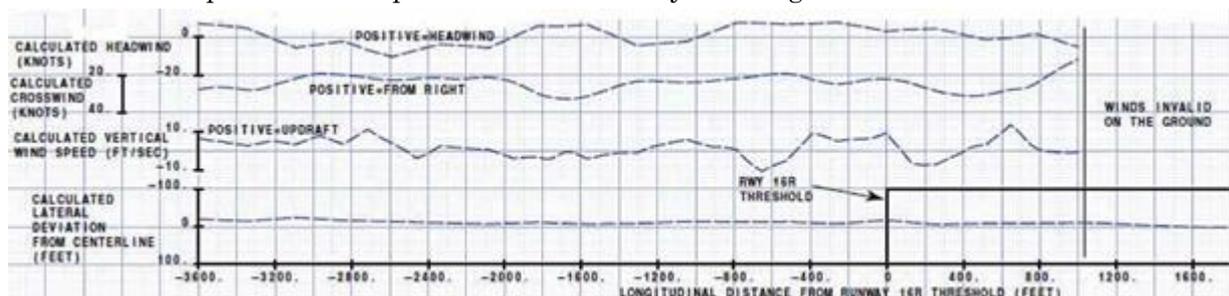
Fig. 2.8.3 (1) Wind analysis by aircraft manufacturer

The crosswind component changed by  $\pm 10$  kt or more during the time period from when the aircraft reached the runway threshold to when it touched down. Besides, the weak headwind component changed to tail wind at the time of the touch-down. All of these wind changes at and beyond the threshold crossing are further evidence of increased workload for the crew member to maintain the path of the airplane over the runway. (See Fig. 2.8.3 (1).)

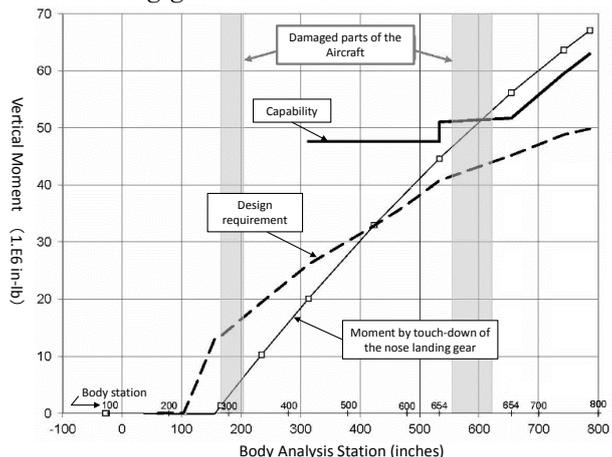
Fig. 2.8.3 (4)-1 Estimation of bending moment (First touch-down of nose landing gear)

The data of the FDR cannot be used for accurate load calculation because the sample rates of the parameters necessary for the calculation is low. Instead, the maximum load on the nose landing gear caused by the accident was calculated based on the damage on the aircraft nose. The result shows that the load on the nose landing gear was 150,000 lb or larger. The estimated load on the nose landing gear indicates that it received a bending moment larger than the design requirement and the structural strength of the fore fuselage. The damage on the fore fuselage could be caused by either or both the first and second hard landings of the nose landing gear. (See Figs. 2.8.3 (4)-1 and 2.8.3 (4)-2.)

Under the assumption that the load of about 150,000 lb was applied to the nose landing gear, Figs. 2.8.3 (4)-1 and 2.8.3 (4)-2 show that the damaged part received a bending moment larger than the design requirement and the structure strength of the forward fuselage. Therefore, it is probable that the damage on the forward fuselage upper crown was caused by either or both of the first and second hard touch-downs of the nose gear.

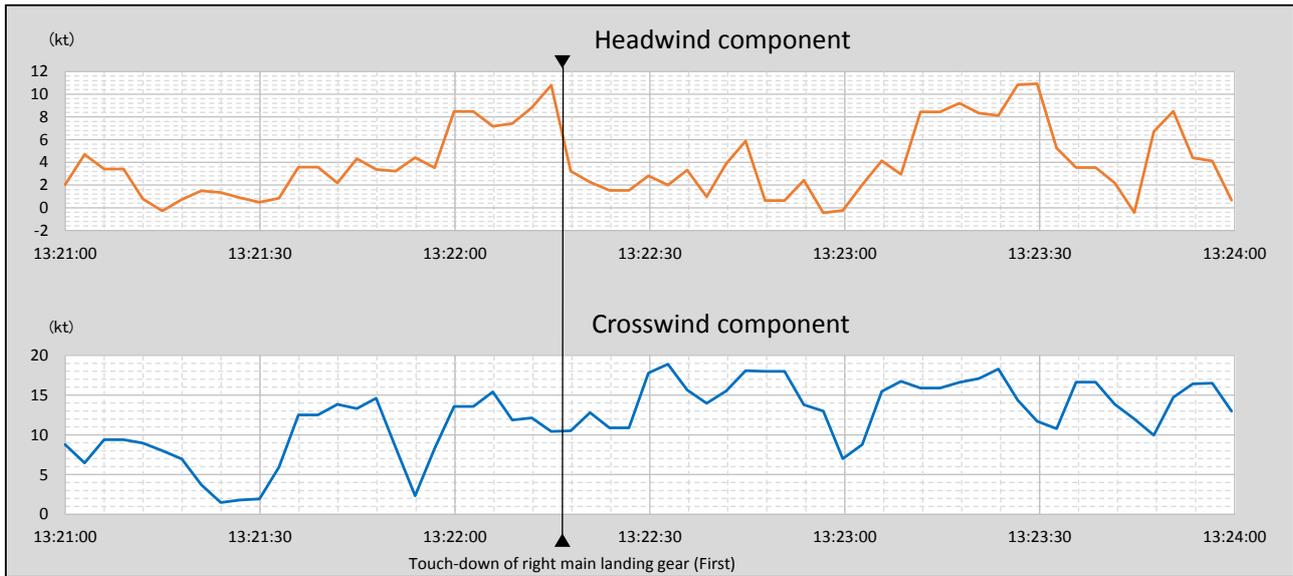
Fig. 3.3.2.2 Headwind and crosswind components before and after the accident

Figure 3.3.2.2 shows the headwind component and crosswind component of the wind at around the time of the accident (13:21 to 13:24) obtained from the observation data of instantaneous wind direction and velocity near the touch-down point on Runway 16R, Narita Airport, described in 2.6.4.

It is probable that the tendency of the wind indicates that the wind velocity changed largely

with a gust.

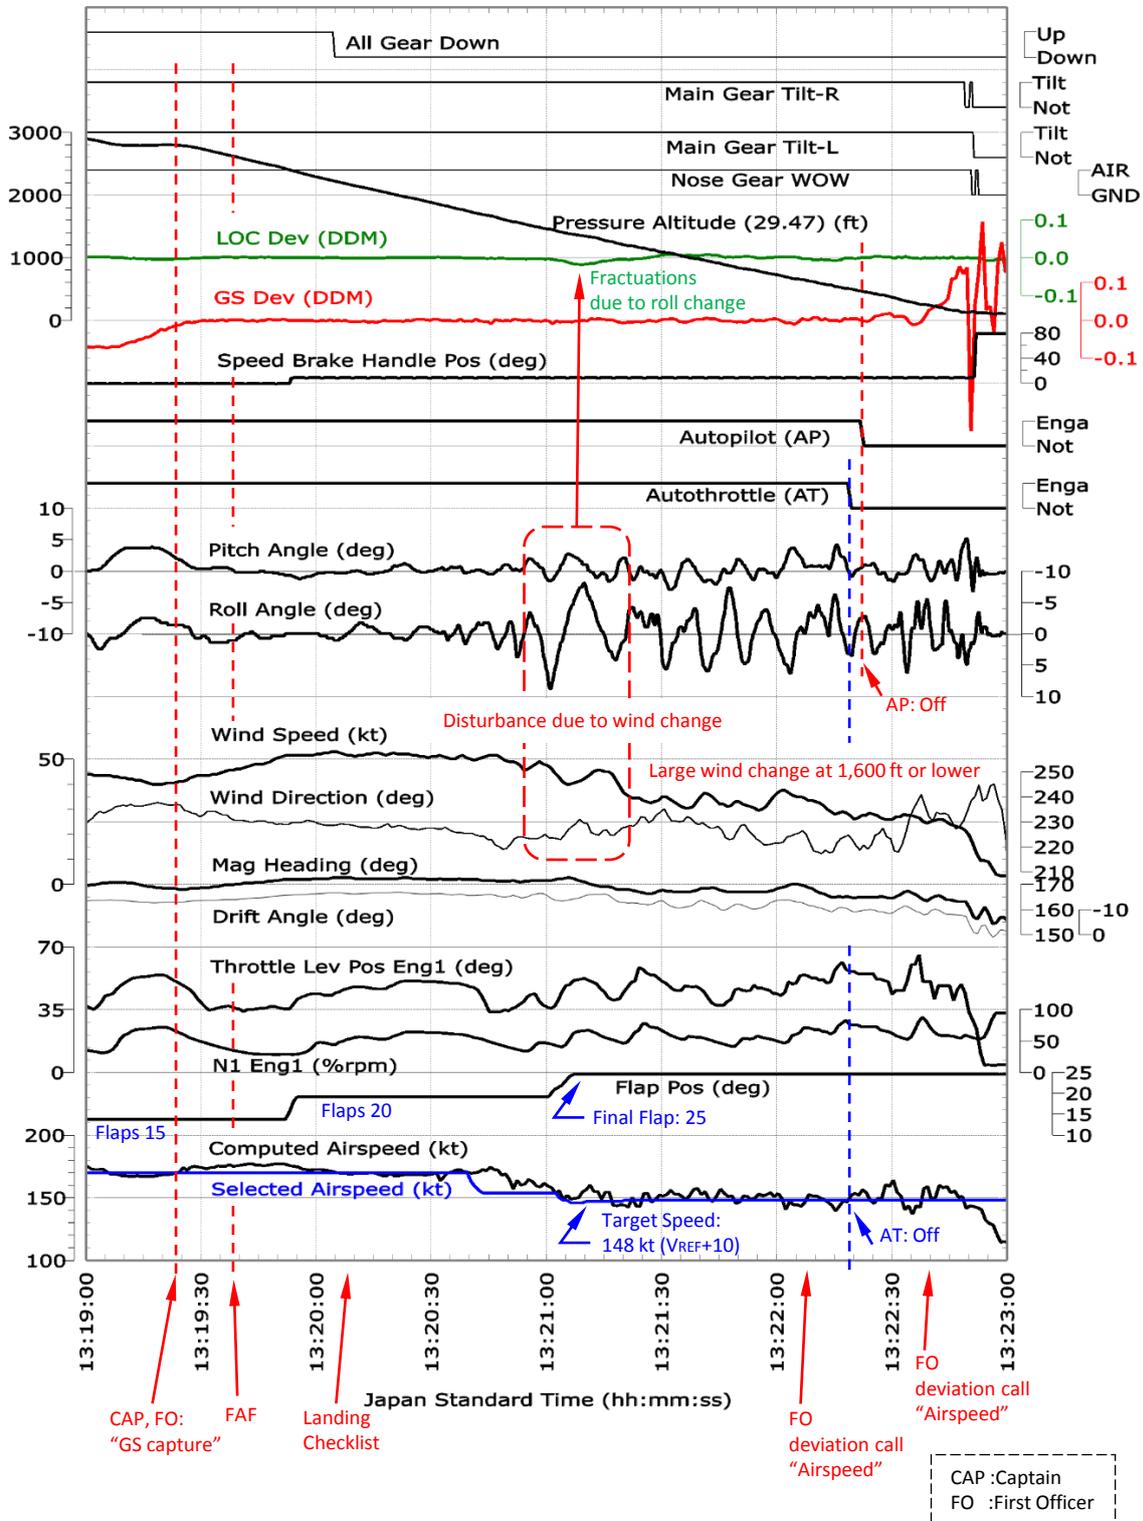
Figure 3-2 FDR Records (600-0 ft)

According to the description in 2.1.1 and Fig. 3-2, the First Officer make a call of the altitude 500 ft at 13:22:10 and the Captain responded saying "Stabilized". At that time, the aircraft attitude was changing significantly but the aircraft was flying on an appropriate approach course and the speed change was not outside the range that required issuing deviation call. Therefore, it is probable that the aircraft was in the stabilized state specified in 2.9.1 and 2.9.2.

According to the description in 2.1.1 and Fig. 3-2, after disconnecting the AT, the aircraft disengaged the AP at an altitude of about 450 ft (altitude above ground level of 340 ft). Since it did not reach the decision altitude (altitude above ground level of 200 ft), it is highly probable that the AP was disengaged to follow the provision of 2.9.1.

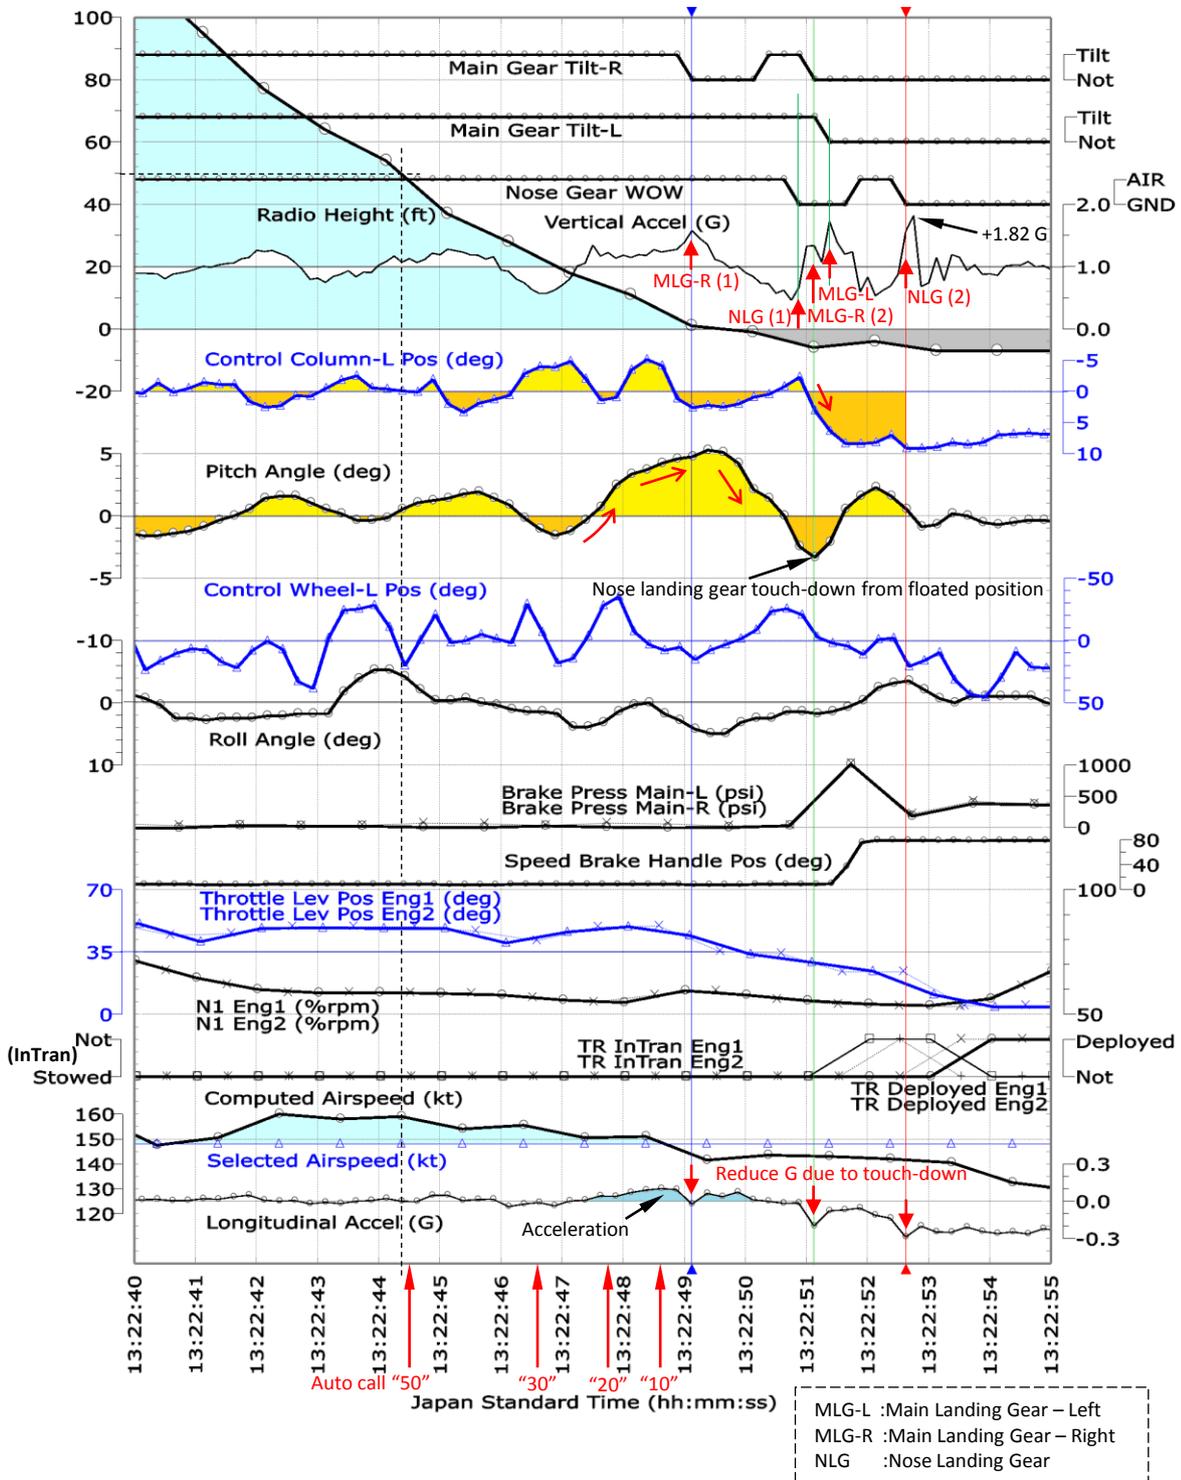
Figure 4 Events in the during Flare  
(Descending Rates and Automatic Calls)

The statements in 2.1.2 (1) indicate that the Captain felt the descent of the aircraft at an altitude above ground of 20-10 ft and the descent rate data shown in Fig. 4 indicates that it was about 400-600 ft/min during the period from when it passed the altitude above ground level of 37 ft at 13:22:45 after passing the runway threshold to when it touched down. Accordingly, it is highly probable that the descent rate could not be sufficiently reduced due to the failure of making appropriate flare operations.
